DOT/FAA/AR-97/9

# An Acoustic Emission Test for Aircraft Halon 1301 Fire Extinguisher Bottles

April 1998

Final Report

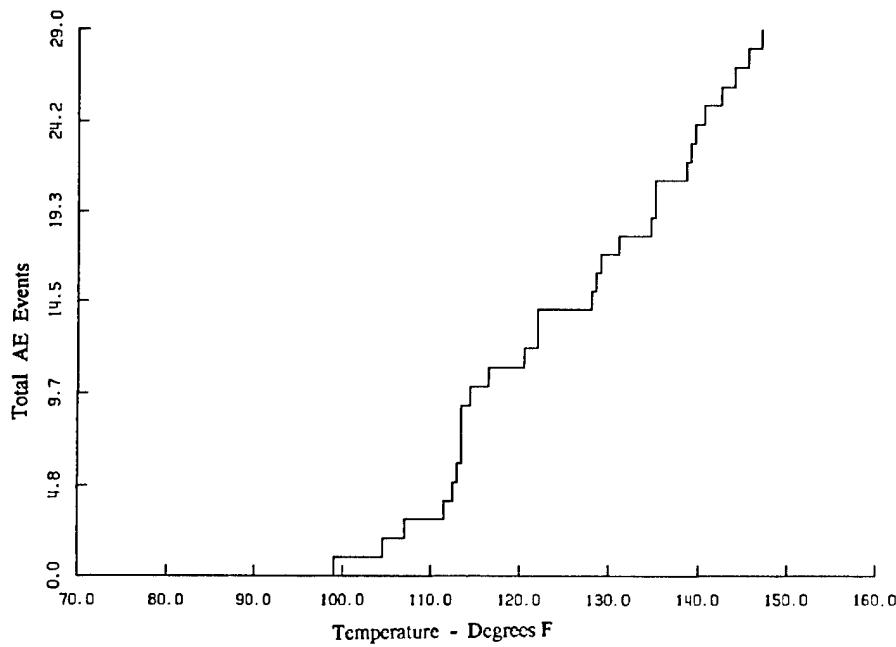
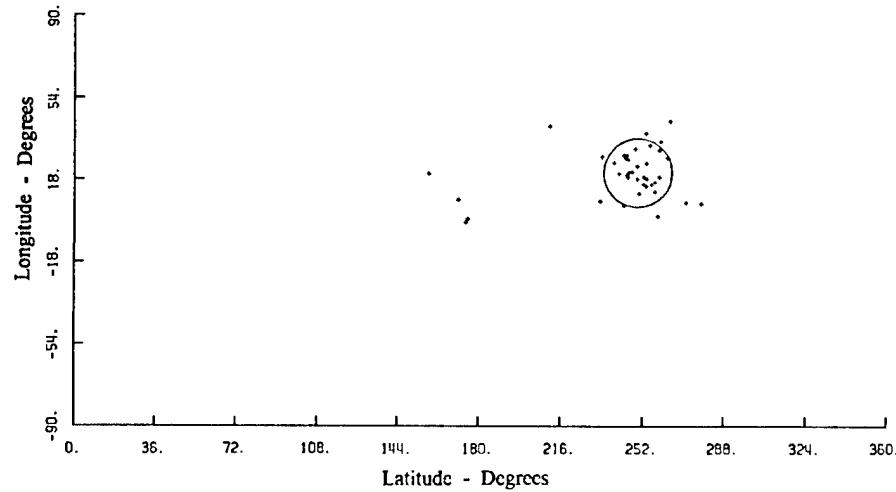
HPAI2569

Location diagrams and event versus temperature data are shown in figures 4 and 5. In figure 4, a serious appearing cluster containing 29 events is shown on the location plot. However, the event rate is constant as the temperature, and thus the pressure, increases. In contrast, figure 5 shows a

FIGURE 4. EVENT VERSUS TEMPERATURE CURVE AND LOCATION PLOT. The slope of the event curve for the cluster is constant with increasing temperature.

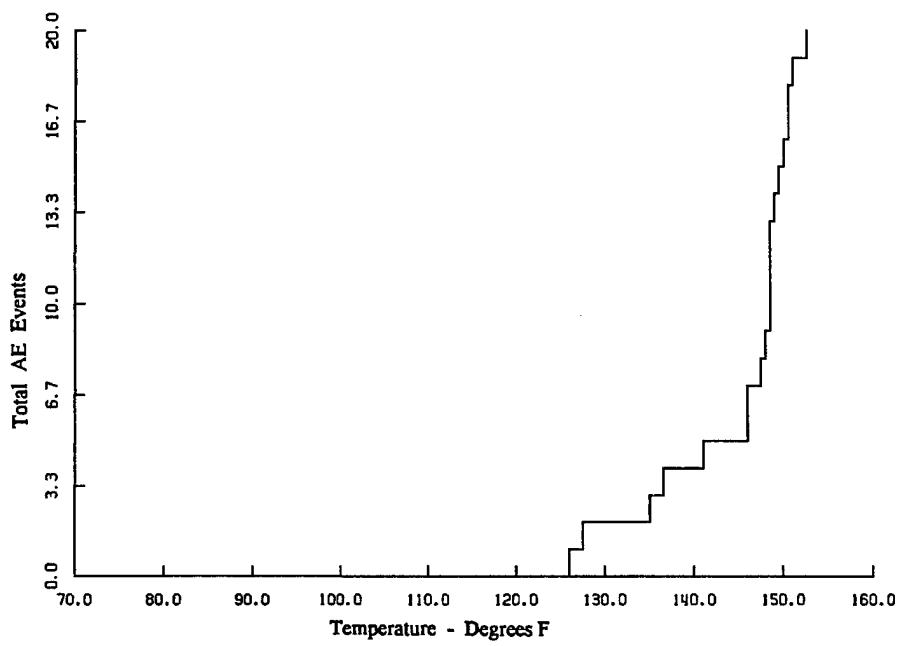
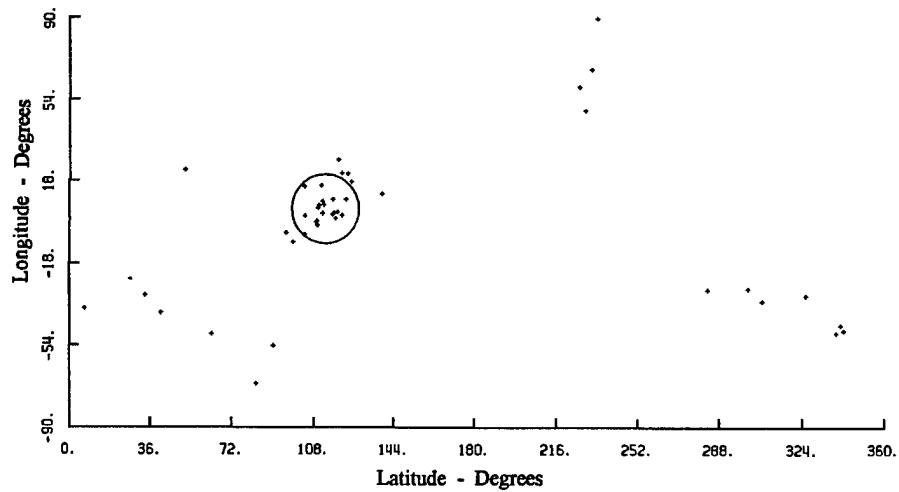
HKAI9355

cluster containing 20 events, but 18 of the 20 events occurred above 130°F. The cluster in figure 5 is located partially over a doubler plate on the bottle. An x ray of this plate showed a tungsten inclusion in the fillet weld holding the plate on the bottle. The fact that the emission did not start until a relatively high temperature and the rapid emission rate above 148°F is strong evidence that a crack is propagating in the weld, starting from the tungsten inclusion. Because

FIGURE 5. EVENT VERSUS TEMPERATURE CURVE AND LOCATION PLOT. The slope of the event versus temperature curve for the cluster shows a significant increase at high temperatures.

the bottle passed a hydrostatic test, the crack is probably not in the vessel wall but instead is propagating within the doubler plate fillet weld parallel to the wall. Thus, it is a real flaw but one which may not result in the failure of the bottle.
